## DRAFT FINAL REPORT

# Crash of Malaysia Airlines Boeing 777-200, 9M-MRD, flight MH17

Hrabove, Ukraine, 17 July 2014

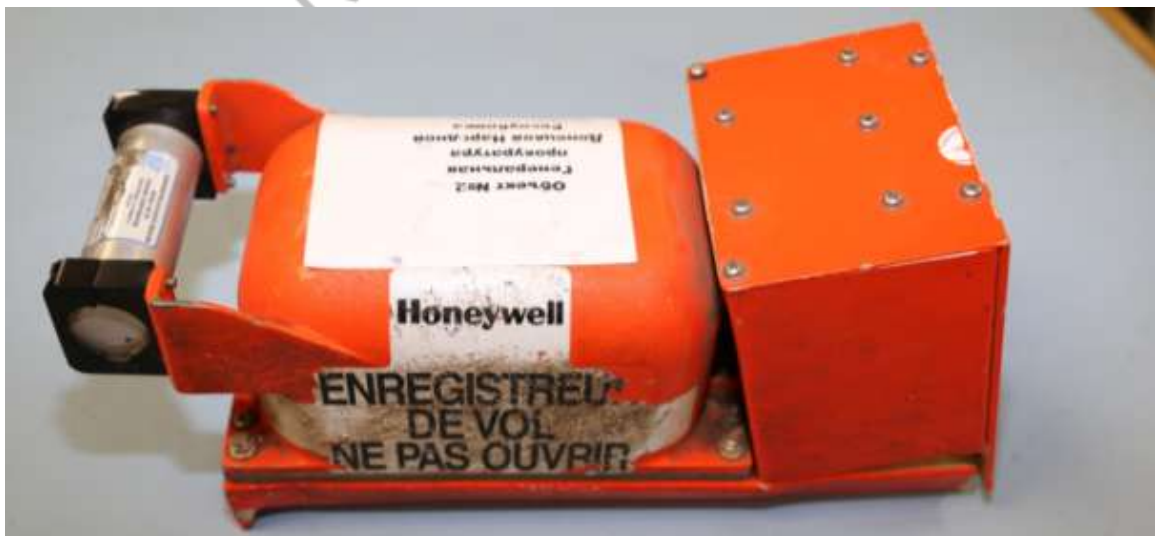
19 The housing of the Cockpit Voice Recorder (Figure 8) was damaged and, although  
20 the model and serial numbers are unreadable on the datum plate, the serial number  
21 1366, matching the one provided by Malaysia Airlines, is stamped on the underside  
22 of the chassis. The external damage on the Cockpit Voice Recorder is consistent  
23 with impact damage; the internal memory module was intact. The Cockpit Voice  
24 Recorder was successfully downloaded and contained valid data from the flight.

27 *Figure 8 – Cockpit Voice Recorder (Source: DSB)*

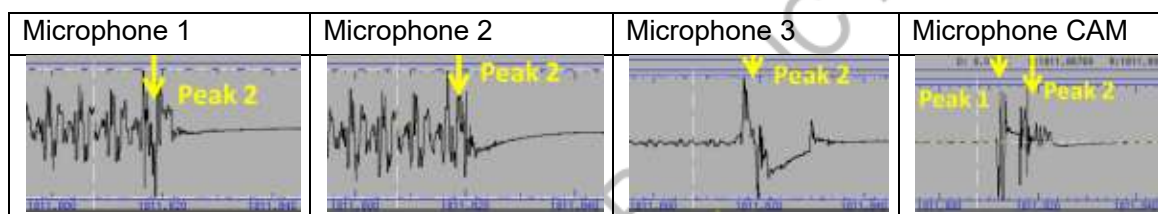
16 *Figure 9 – Sound peaks recorded at the end of the CVR recording (Source: DSB)*

18 The time period shown on each image is four hundredths of a second. It is noted  
 19 that peak of sound 'peak 1' is only recorded on the CAM.

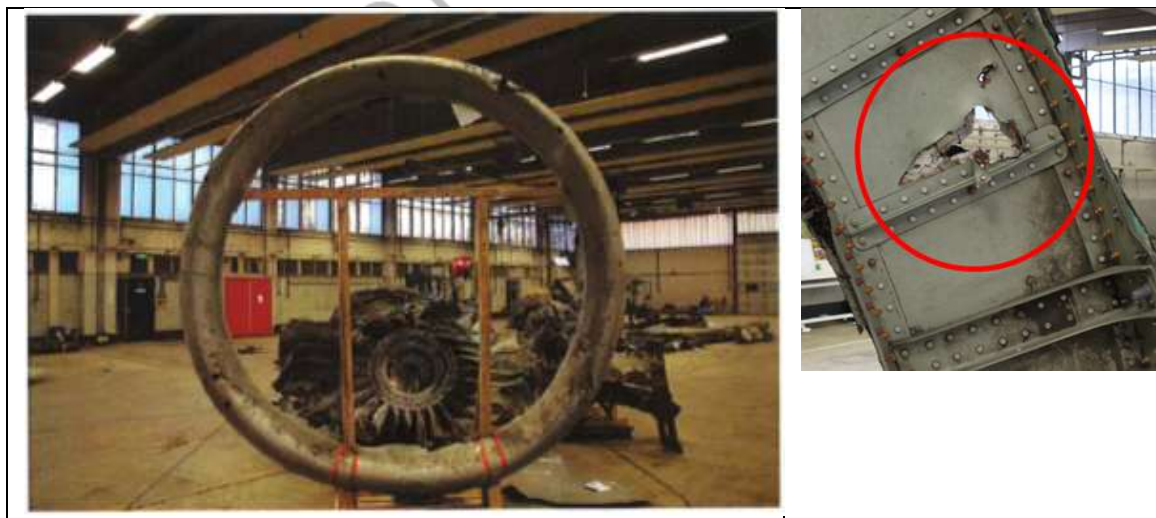
21 The leading edge of the left engine casing was found in the south-eastern region of  
22 area 2. The ring showed penetration damage on approximately the 40, 50, 60, 135,  
23 180, 200, 290 and 300 degree positions, looking forward.

25 *Figure 14 – Damaged left engine nacelle leading edge (left) and impact marks at*  
26 *the 200 degree position shown from the rear side (right) (Source: DSB)*

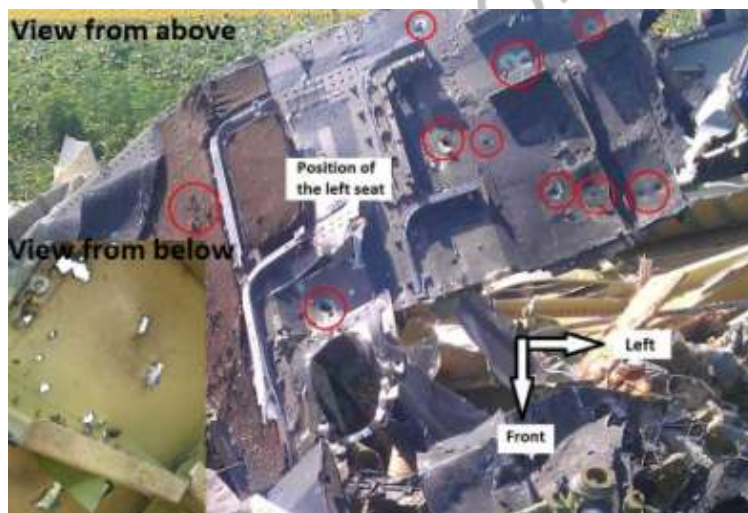
13 *Figure 16 - Cockpit floor with floor parts showing penetration holes (red circles)*  
 14 *coming from above the floor, penetrating downwards (source: NBAAI)*

16 A large part of the cockpit floor was recovered, Figure 16, broken up in several  
 17 parts, and stripped from most of its contents. Seats, centre console, wall structure  
 18 and most of the control mechanics were separated from the floor structure; only part

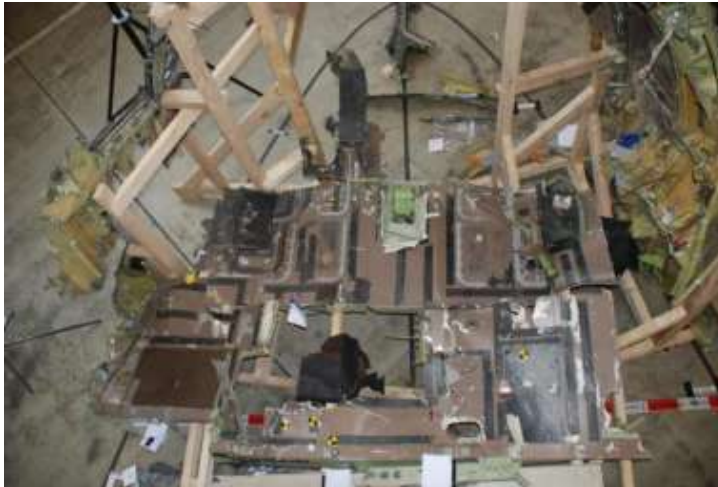
4  
5 *Figure 17 - Cockpit floor overview partially reconstructed in Gilze-Rijen (Source:*  
6 *DSB)*

7  
8 The outer left side, effectively left of the captain's seat, is covered in soot and has a  
9 large number of holes of different sizes are noted. The curved metal parts on the  
10 floor are the forward and aft tracks of the captain's seat. Smaller numbers of impact  
11 holes were present in other locations, including just left of the first observer seat and  
12 below the second observer seat.

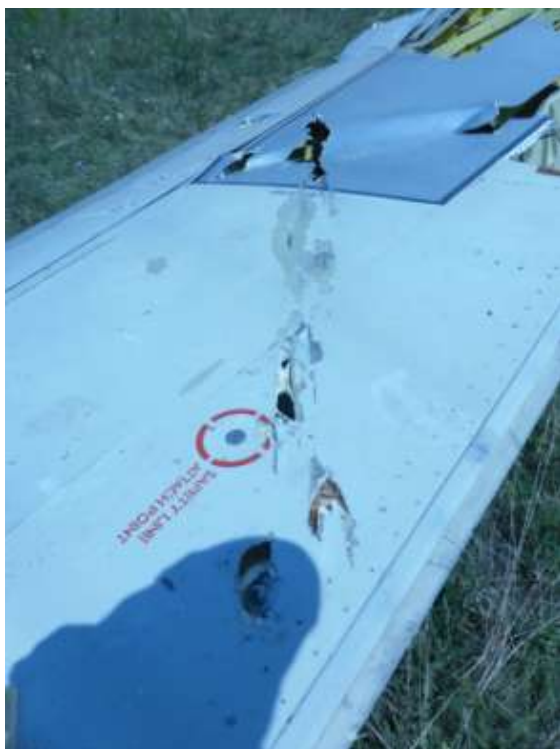
2 The left wing tip was located near the pond in the south easterly region of area 4,  
3 with its top side facing upwards and the tip in a north westerly region. The Safety  
4 Line Attach Points were visible on the top side of the wing tip. The tip showed signs  
5 of impact damage on the top side and the leading edge. The wing tip broke off from  
6 the wing at the fourth fuel tank vent hatch, counting from the tip towards the root.  
7

9 *Figure 18 – Left wing tip with impact damage (Source: ATSB)*

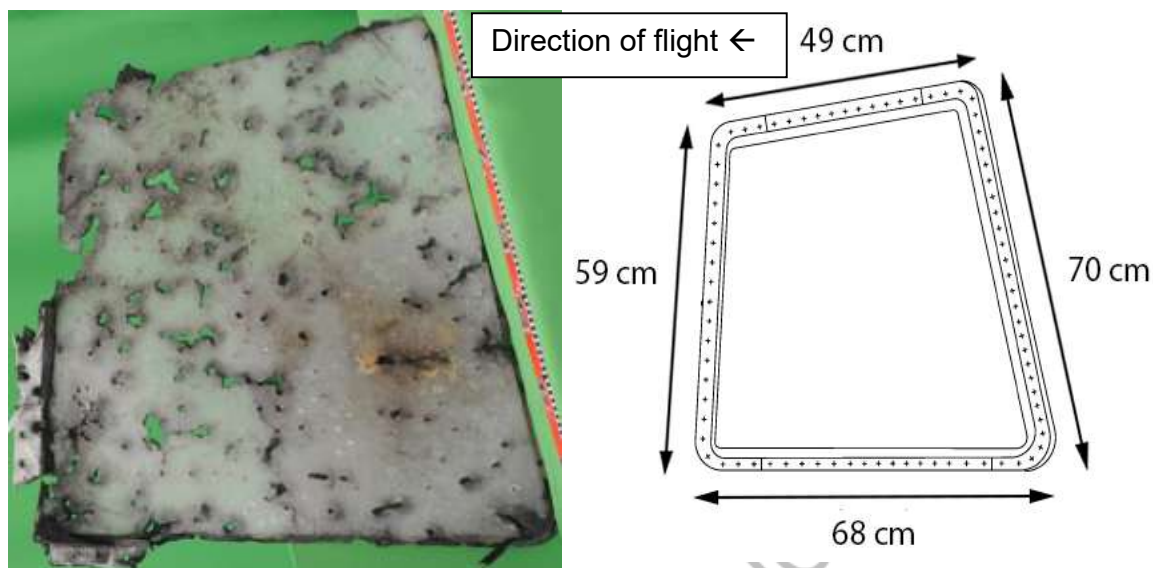
24 One of the layers of the centre window (window number 2) on the left hand side of  
25 the cockpit was collected by local residents. The cockpit windows are made of  
26 multiple layers of glass and plastic. The window had a total of 102 puncture holes

- 1 and marks, varying in size and shape, as seen in Figure 20. Parts of the window  
 2 frame were still attached to the window.  
 3

4 *Figure 20 – Centre cockpit window left hand side (Source: DSB)*

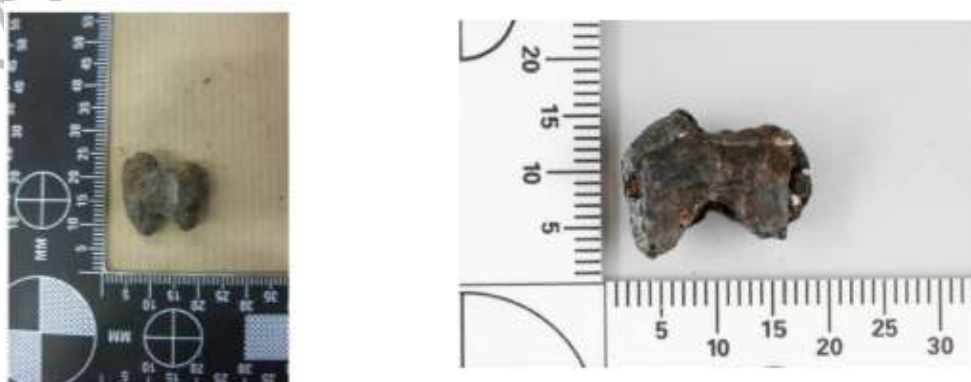
20 In the course of the investigation over 500 foreign objects were recovered. In the  
21 wreckage of the aeroplane and in the bodies of the flight crew members a number  
22 of non-aircraft fragments were found that were suspected to be high-energy objects,  
23 or parts of them. A number of these fragments had a distinct butterfly or bow-tie  
24 shape, such as the one shown in the images below, and were magnetic.

26 *Figure 21 – Fragments found with butterfly or bow-tie shape. The right hand*  
27 *fragment was found in the body of a flight crew member (Source: NFI)*

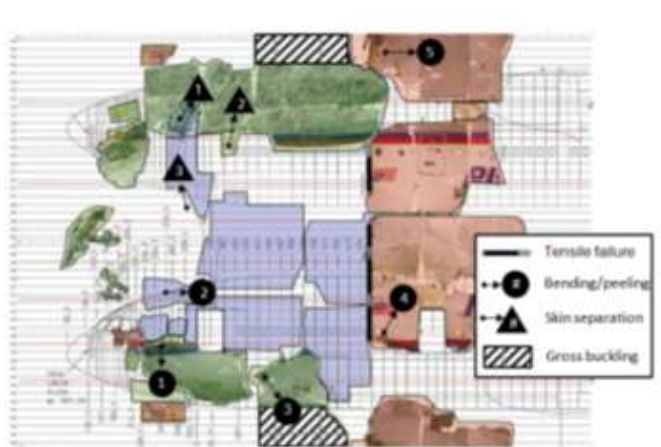
24 The overall distribution of these observed features is illustrated on the  
 25 reconstruction grid in Figure 53. It is noted that some of these features are indicated

4  
 5 *Figure 53 – Overview of the forward fuselage wreckage parts indicating major*  
 6 *break-up features*

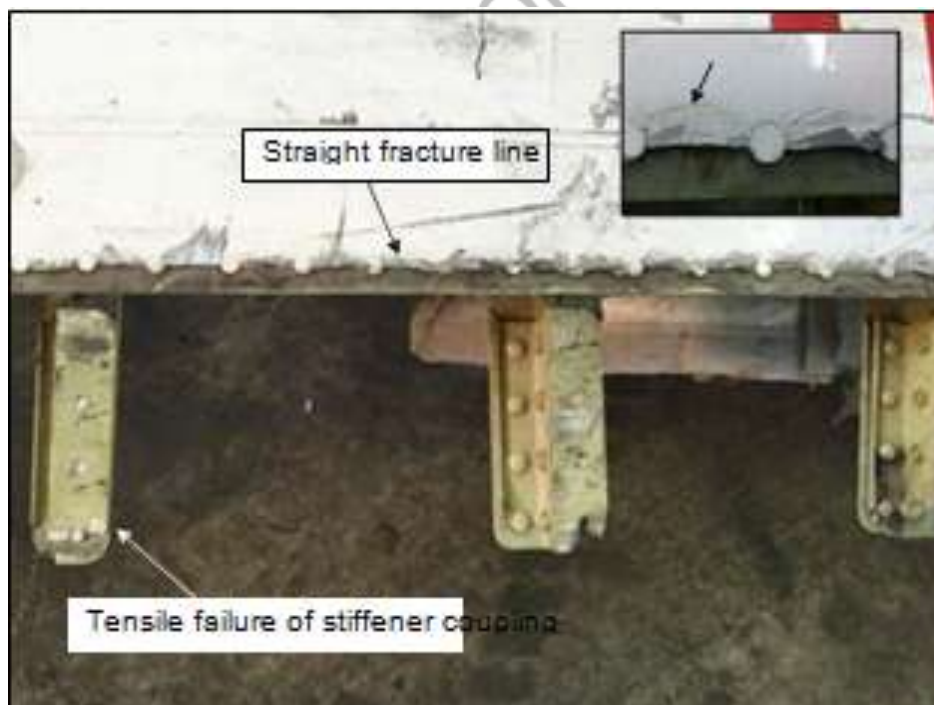
- 10  
 11 An example of tensile overload failure this type of fracture is given in Figure 54.  
 12

13  
 14 *Figure 54 – Typical case of pure tensile overload failure; straight cracks in net-*  
 15 *section, paint cracks aligned with skin crack, stiffener coupling failure at the first*  
 16 *fastener*

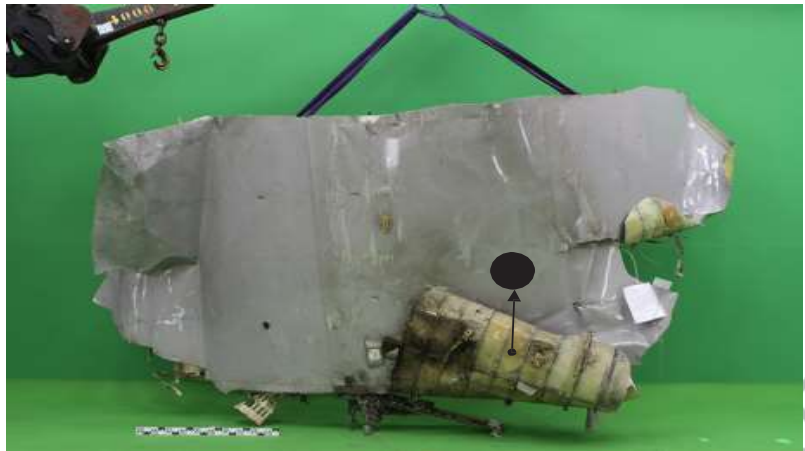
Figure 55 – Example of bending/peeling at a fracture line located along STA655 associated with the final separation between two pieces of wreckage.

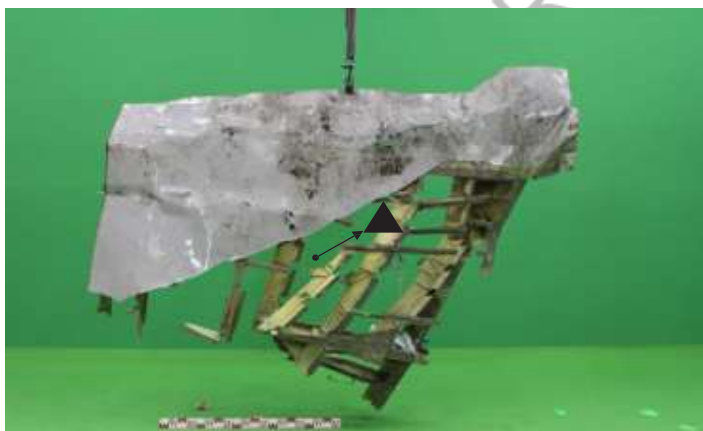
Figure 56 – Example of skin/sub-structure separation in the nose section immediately forward of the door 1R.

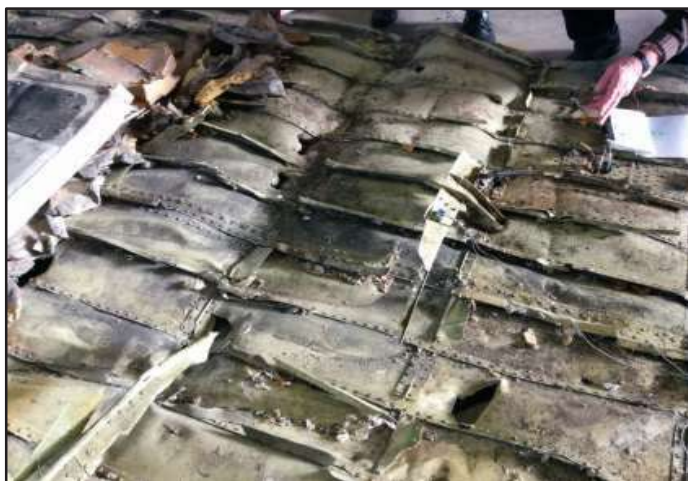
1  
2  
3  
4  
Figure 57 – Example of gross buckling of the lower fuselage skin panel near STA487.

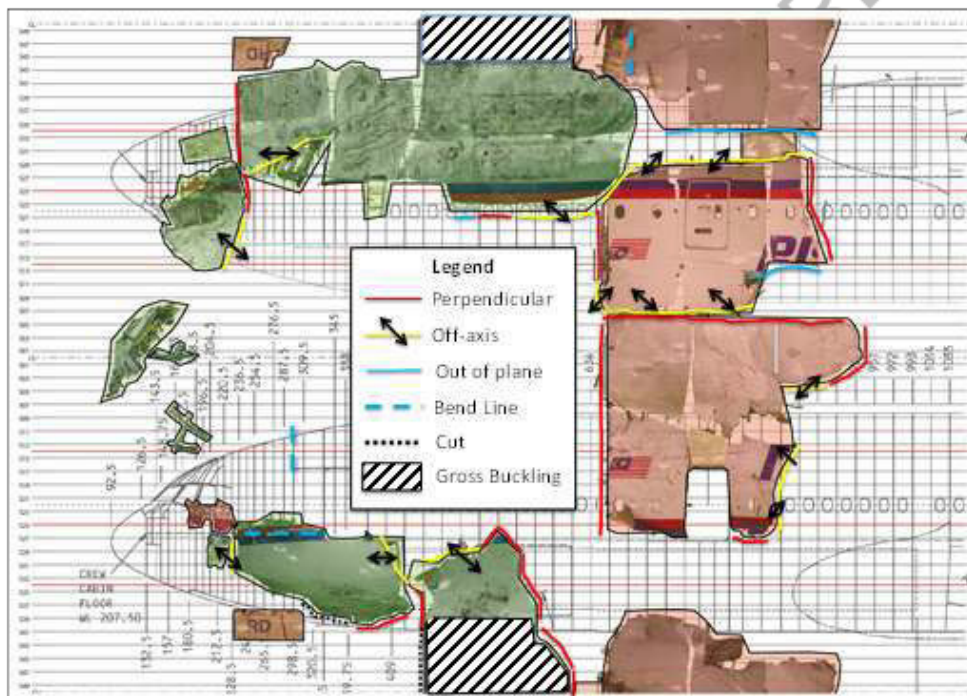
5  
6  
7  
8  
9  
Figure 58 – Overview of forward fuselage wreckage parts indicating the modes of fracture in detail

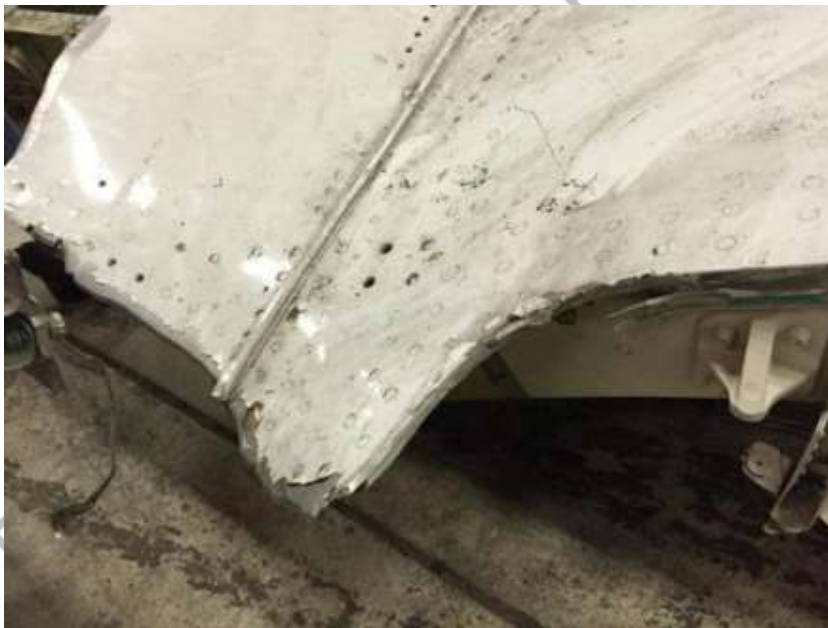
14 Only a panel of the side shell has been found and was examined. For the left panel,  
15 this concerns fractures from the upper right door corner of passenger door 3L  
16 upward, and fracture from the lower right corner downward. Both fractures together  
17 align into a vertical fracture. Both fracture surfaces exhibit fractures consistent with  
18 tensile overstress fracture.

21 *Figure 59 – Tensile overstress fracture at the upper right door corner of passenger*  
22 *door 3L*  
23

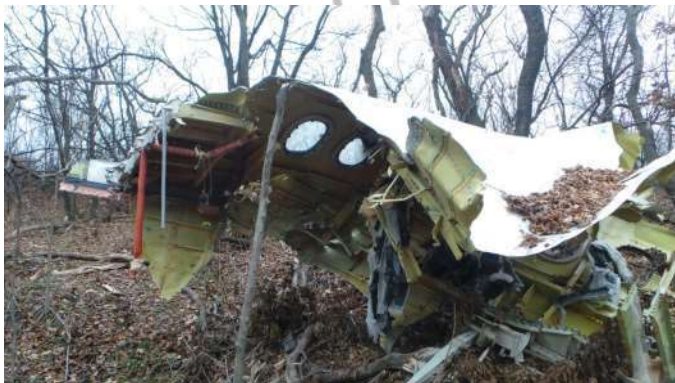
15  
16 In the area investigated, no repairs were observed. Traces of fatigue or corrosion  
17 were not found.

19  
20 *Figure 63 – Severely deformed fuselage structure aft of passenger door 3R,*  
21 *including aft cargo door surrounding structure (source: DSB)*
