Left Engine Failure and Subsequent Depressurization  
Southwest Airlines Flight 1380  
Boeing 737-7H4, N772SW  
Philadelphia, Pennsylvania  
April 17, 2018

NTSB/AAR-19/03  
PB2019-101439

National  
Transportation  
Safety Board

# Aircraft Accident Report

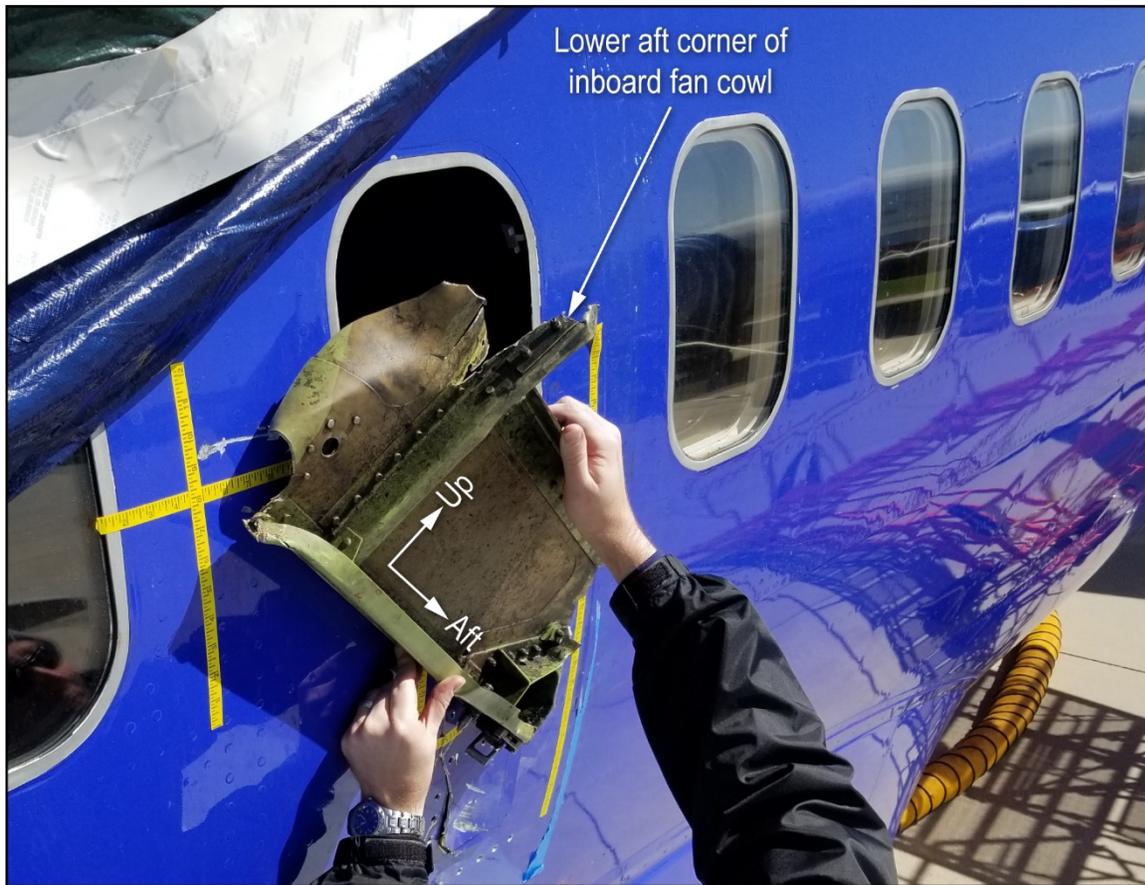
**Figure 6.** Lower aft corner of inboard fan cowl aligned with witness marks on fuselage.

Note: The window by seat 14A is behind the inboard fan cowl piece shown in the figure.

One portion of the fan cowl that was recovered after the accident was the inboard aft latch keeper. The left side of the fuselage near the location of the missing cabin window (adjacent to seat 14A) had impact damage and witness marks that were consistent with the size and shape of the inboard aft latch keeper and surrounding fan cowl structure, as shown in figure 6.

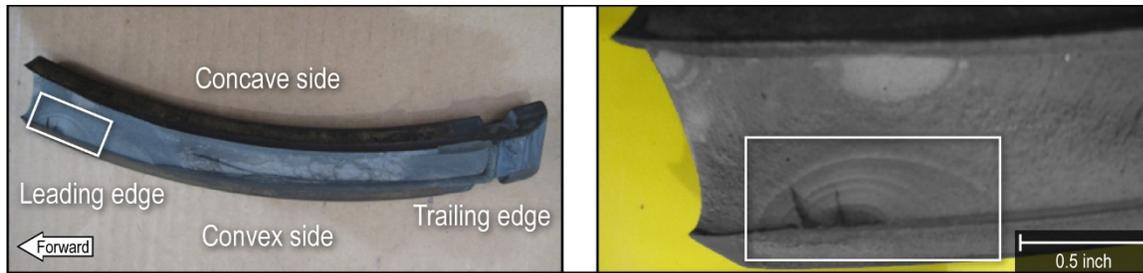
All but 1 of the 24 fan blades were found as installed (full length) in the fan disk; fan blade No. 13 had fractured at the root.<sup>41</sup> A visual examination of the fractured blade's dovetail, which remained installed in the fan disk, found features consistent with a fatigue crack that initiated on the convex side about 0.6 inch aft of the leading edge, as shown in figure 7.

**Figure 7.** Fatigue indications on fan blade fracture surface.

Note: The fan blade fracture surface is shown resting on its inboard face. The part of the blade outlined by the rectangle in the left image corresponds with the area of the blade outlined by the rectangle in the right image. The fatigue indications are shown in greater detail in figure 16.

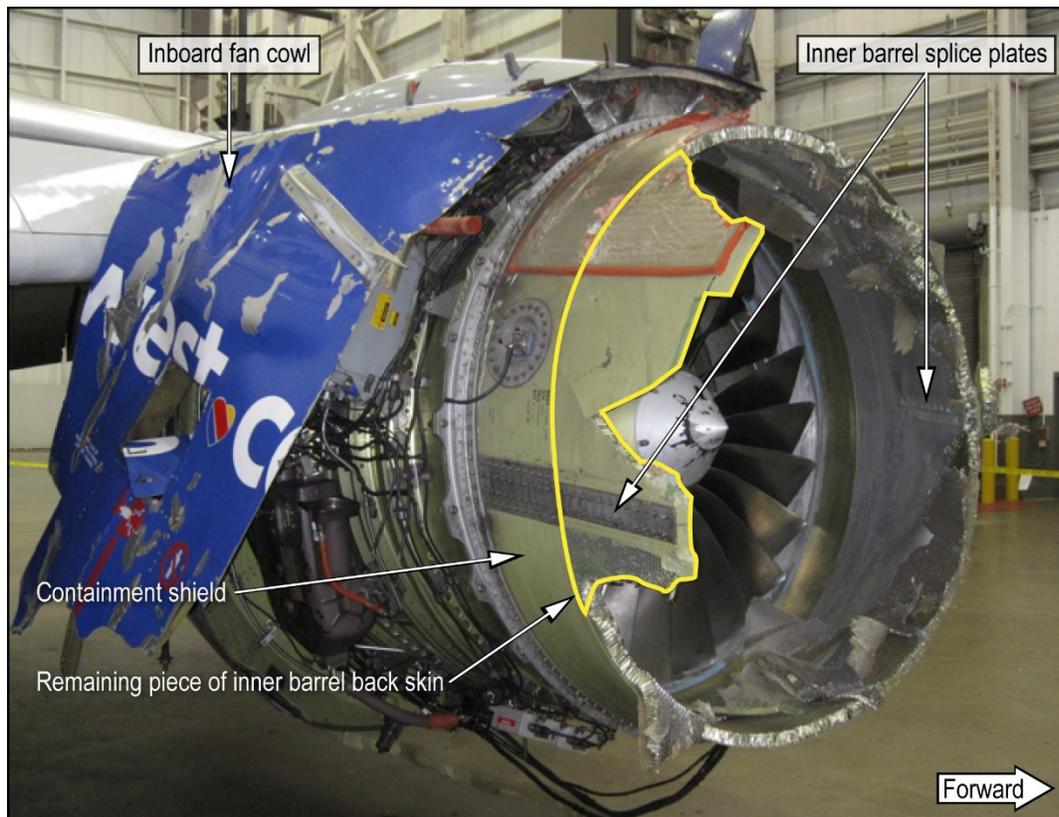
the inlet; only a portion of the inner barrel back skin remained from the one to three o'clock positions and at the five o'clock position. The inner barrel separation location was about 17 inches forward of the fan case A1 flange. The inner barrel perforate skin was missing or torn in various locations around the inner barrel circumference. The two bolted inner barrel splice plates (where the two halves of the inner barrel join) were still present.

**Figure 8.** Inlet damage.

The containment shield was intact with no penetrations, and all of the bolts that secured the containment shield to the inlet attach ring were present. The attach ring was intact and secured to the fan case A1 flange by each of the inlet-to-fan case bolted assemblies. All of the bolted assemblies were intact, and some of the crushable spacers were compressed.

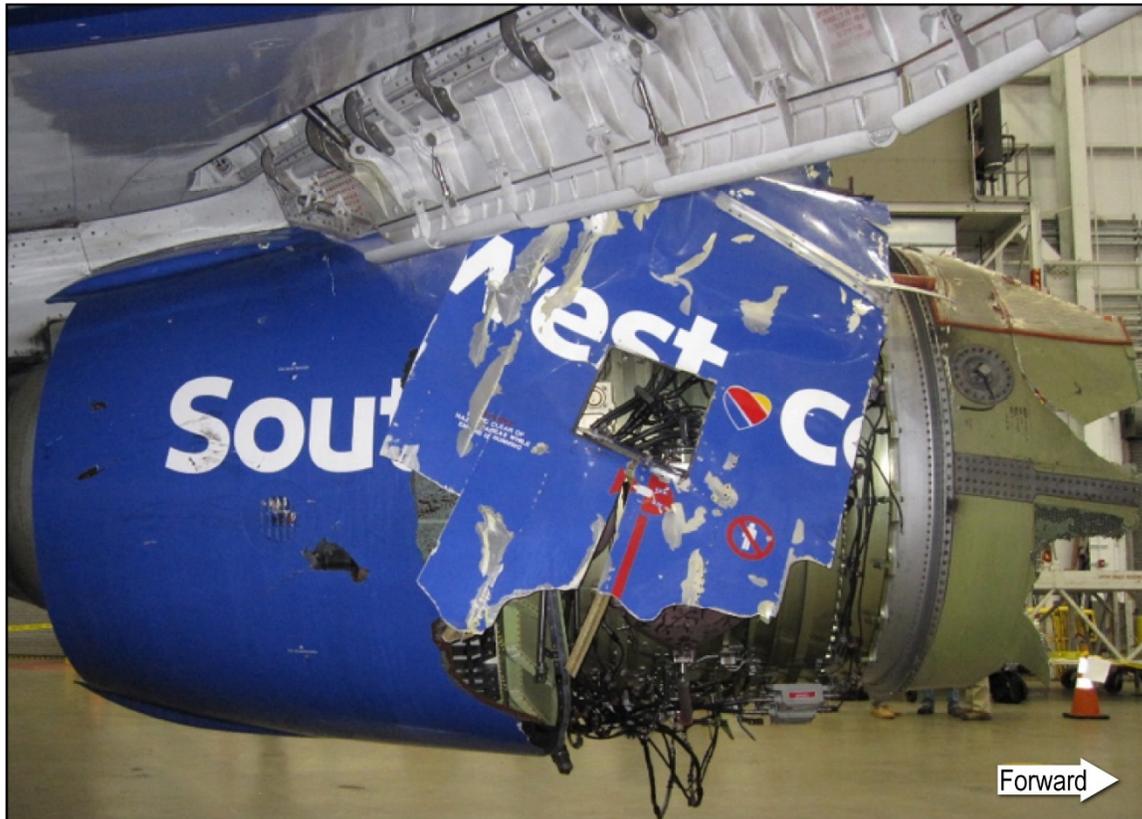
**Figure 9.** Inboard fan cowl damage.

About 65% of the outboard fan cowl and 30% of the inboard fan cowl were recovered separately from the airplane.<sup>46</sup> The recovered pieces showed multiple fractures in the circumferential stiffening frames and areas of missing paint, but those pieces showed no signs of through-hole penetrations.

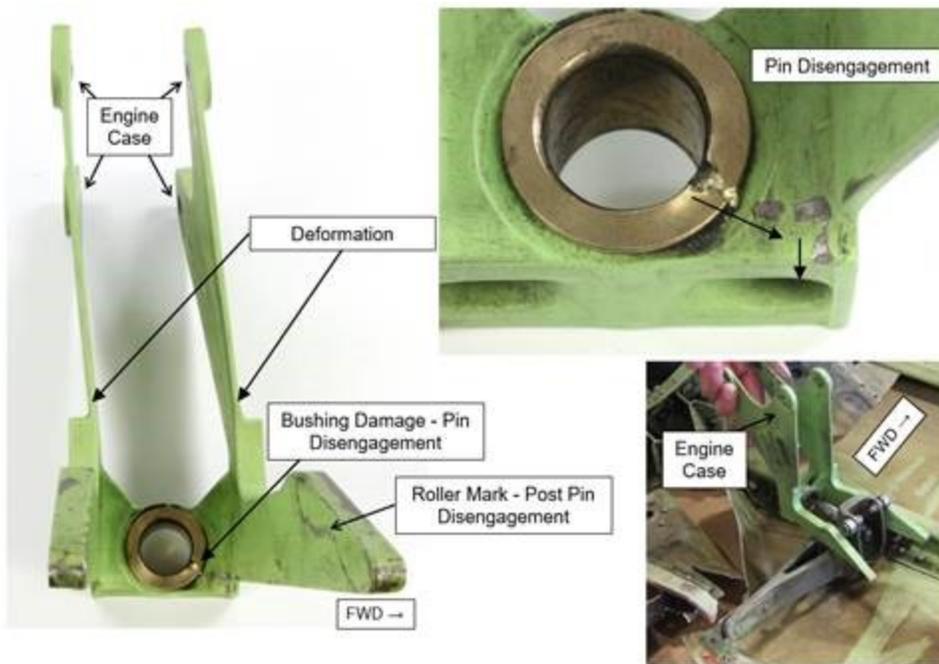
In addition, the radial restraint bracket (located at the bottom of the engine fan case) showed significant damage at the locations where the bracket contacted the radial restraint fitting (attached to the inside of the inboard fan cowl). The bracket was deformed, its bushing flange was damaged, and a roller contact mark was observed, as shown in figure 10. The damage to the radial restraint bracket was caused by the disengagement of the radial restraint pin (an integral part of the radial restraint fitting) as it moved downward and forward relative to the bracket.

**Figure 10.** Radial restraint bracket damage.

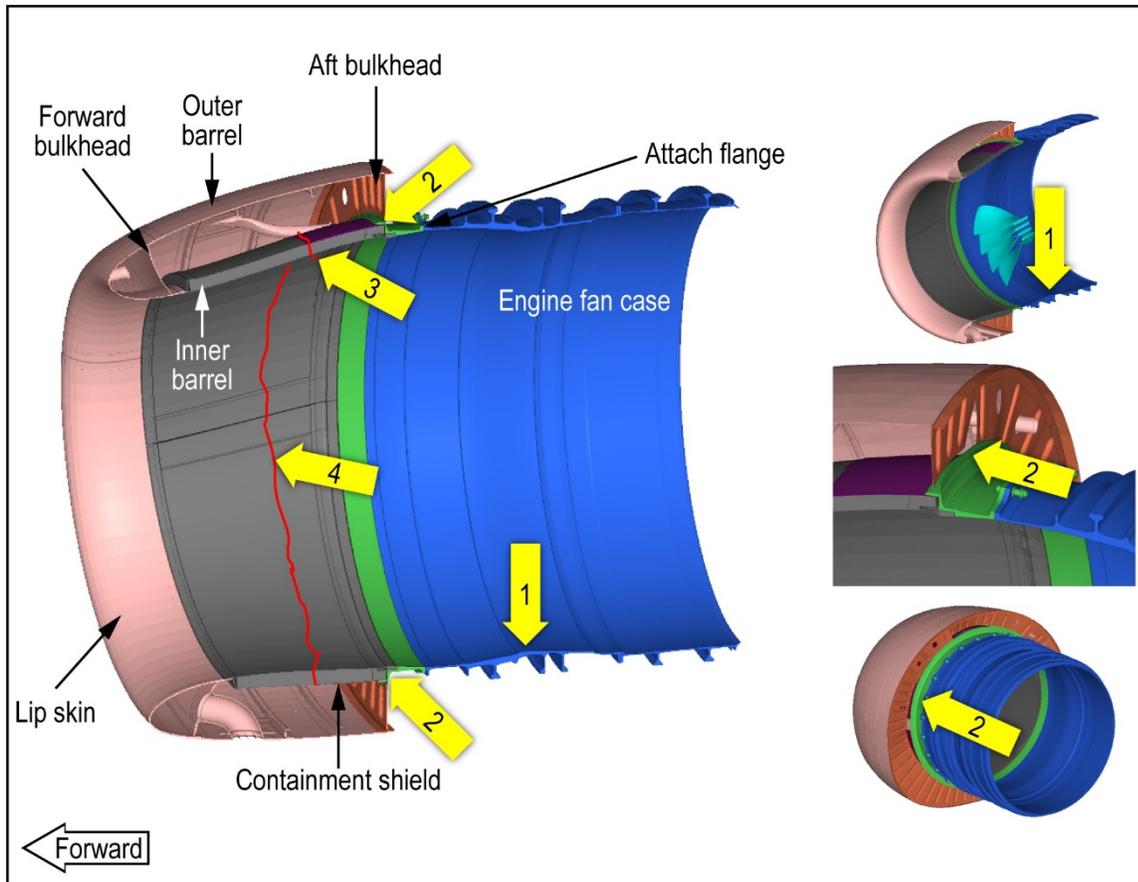
**Figure 13.** Predicted inlet failure sequence.

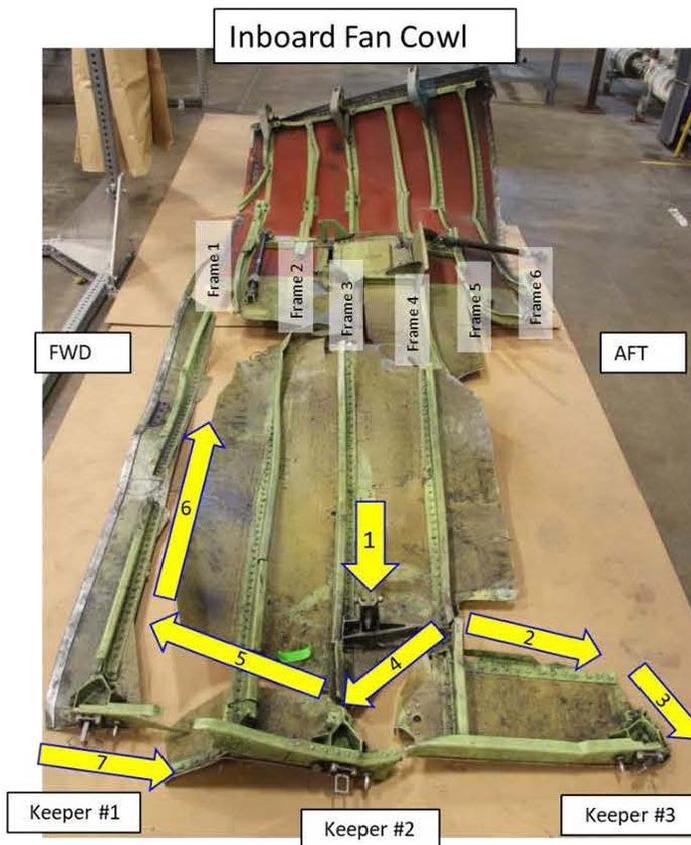
Order of events	Event	Time after fan blade release (second)
1	Radial restraint fitting transmits load into fan cowl (due to fan blade impact at six o'clock position), pin disengages, and multiple cracks in starter vent fitting initiate	0.028
2	Cracks initiate at corners of starter vent	0.038
3	Cracks run in skin to aft edge of fan cowl	0.062
4	Load on aft latch fails skin between frames 4 and 3	0.070
5	Skin crack runs from under frames 2 to 1	0.070
6	Crack turns and runs aft of frame 1	>0.070
7	Load on forward latch fails latch fitting	>0.070

**Figure 14.** Predicted fan cowl failure sequence.

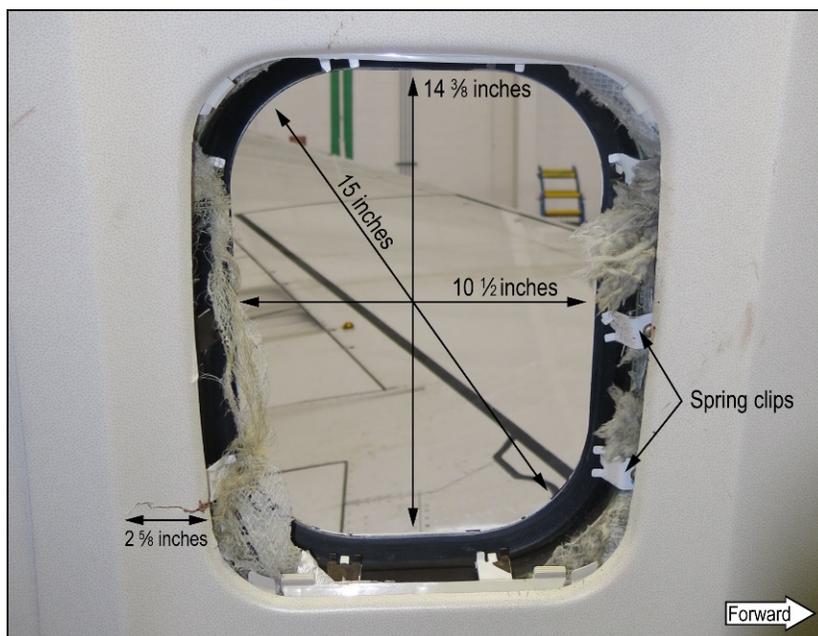
- [The impact of the inboard fan cowl aft latch keeper with the fuselage near the cabin window adjacent to seat 14A caused the window to depart the airplane, the rapid depressurization of the cabin, and the passenger fatality.](#)

**Figure 15.** Window by seat 14A after the accident and window dimensions.

Note: The window is shown from the inside of the cabin looking outside.

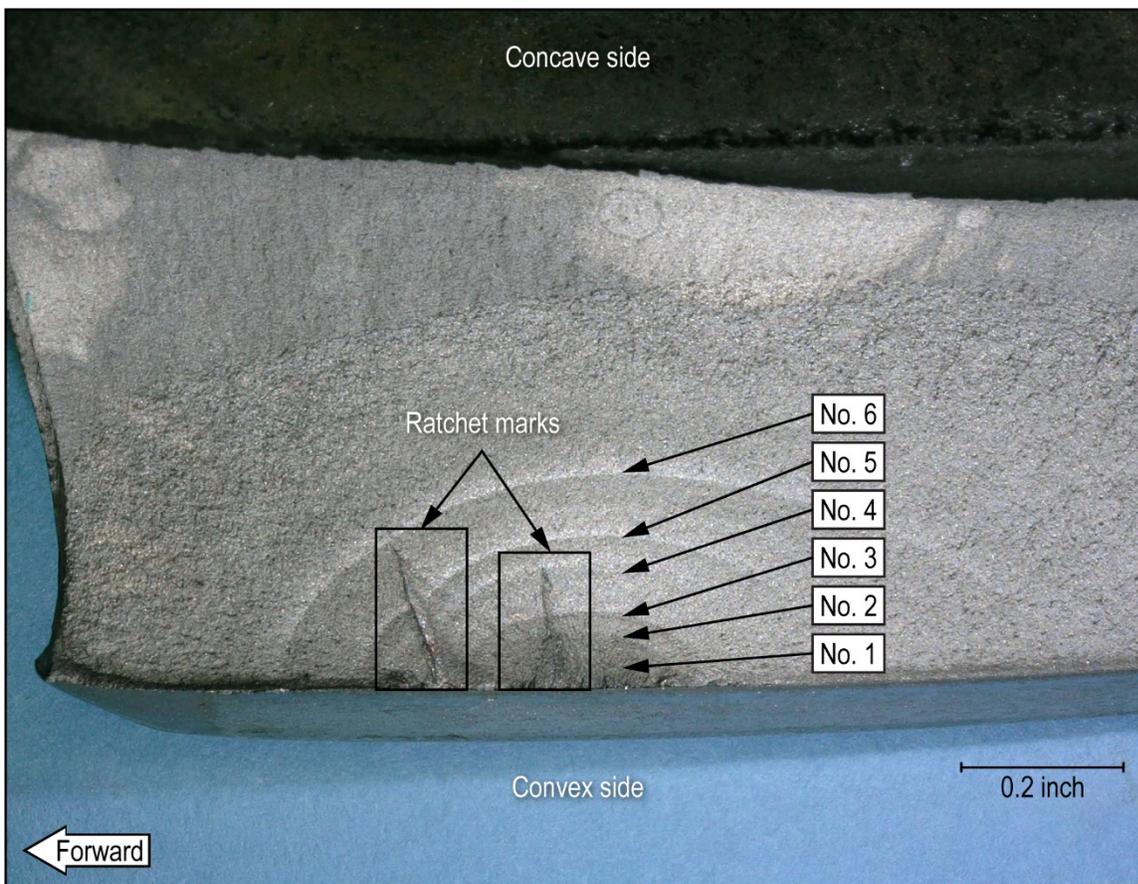
- [The low-cycle fatigue crack in the fan blade dovetail initiated because of higher-than-expected dovetail stresses under normal operating loads, and this crack was most likely not detectable during the fluorescent penetrant inspection at the time of the fan blade set's last overhaul and subsequent visual inspections at the time of fan blade relubrications.](#)

**Figure 16.** Crack arrest lines and ratchet marks in fatigue origin area.

The six crack arrest lines were a portion of the fatigue region that was 0.976 inch long axially at the fan blade surface and had a maximum depth of 0.263 inch. (The depths of the crack arrest lines ranged from 0.037 to 0.263 inch for arrest lines 1 through 6, respectively.) Beyond that area, fracture features were in a relatively flat plane that was 2.232 inches long axially and had a maximum depth of 0.483 inch. Beyond the flat-plane fatigue region, the fracture surface had features that were consistent with ductile overstress fracture. The blade coating was intact and appeared generally uniform in texture and color on both the convex and concave sides of the dovetail without any spalling (flaking of material).

- [The requirement to perform an eddy current inspection at the time of fan blade overhaul and an ultrasonic inspection at the time of blade relubrication should enable cracked fan blades in CFM56-7B engines to be detected and removed from service before the cracks reach a critical size and the blades fracture.](#)

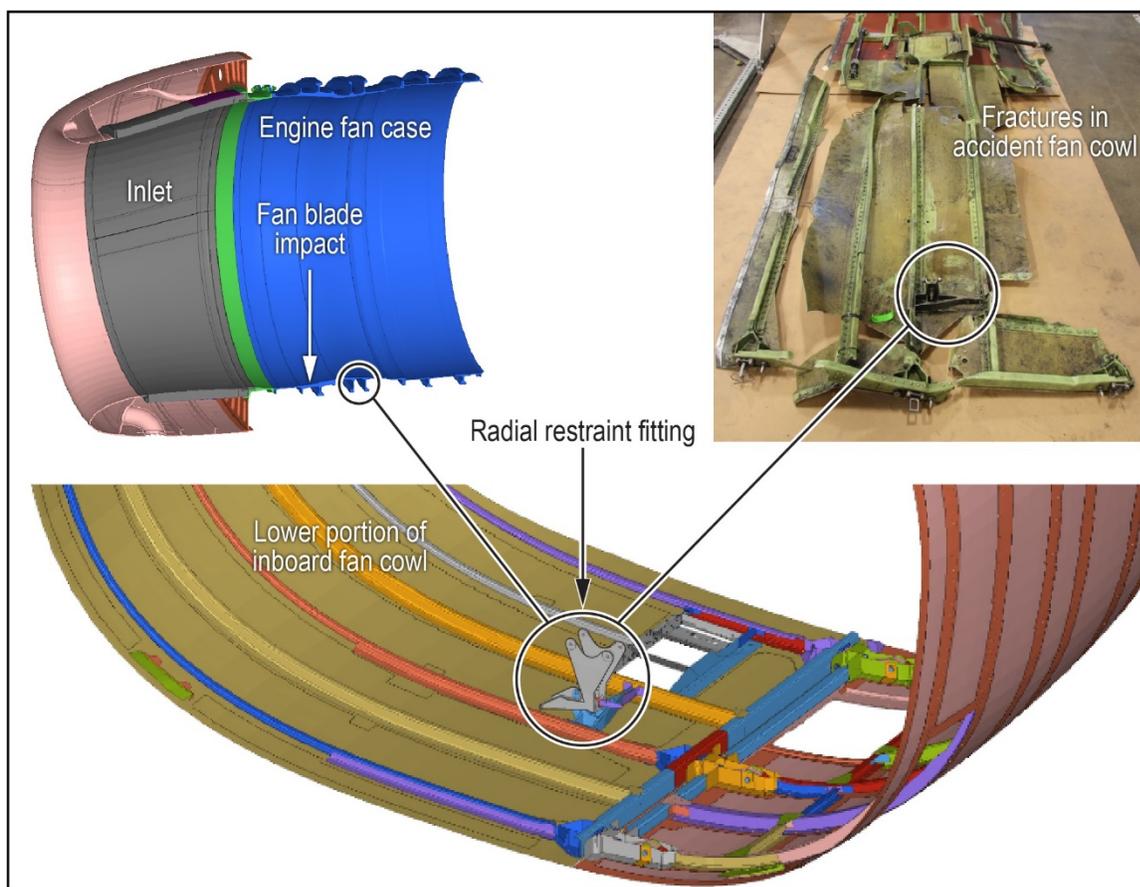
During the accident FBO event, the fan cowl fractured, and portions of the fan cowl departed the airplane. After the accident, Boeing used the damage to the recovered fan cowl hardware, the fan case impact damage, and the predicted interface loads for the accident condition to model the fan cowl damage sequence and perform a progressive failure analysis. This analysis, as well as other Boeing postaccident analyses, found that the fan cowl structure is more sensitive and more likely to fail when a separated fan blade impacts the fan case near the six o'clock position (the bottom of the engine), which occurred during the PHL accident, than at the twelve o'clock FBO release position used during the engine FBO containment certification tests. The fan cowl's higher sensitivity and greater susceptibility of failure from loads resulting from an FBO impact near the six o'clock position were due to the proximity of this FBO impact location to the radial restraint fitting, as shown in figure 21. If the radial restraint fitting does not completely fail or disengage immediately after an FBO event (as designed), the fitting would be capable of transmitting loads from the fan case to the fan cowl.

**Figure 21.** Location of the radial restraint fitting on the fan cowl and in relation to the fan case.

- Once the actions requested in Safety Recommendation A-19-17 are completed, require Boeing to install the redesigned fan cowl structure on new-production 737 next-generation-series airplanes. (A-19-18)

- Once the actions requested in Safety Recommendation A-19-17 are completed, require operators of Boeing 737 next-generation-series airplanes to retrofit their airplanes with the redesigned fan cowl structure. (A-19-19)

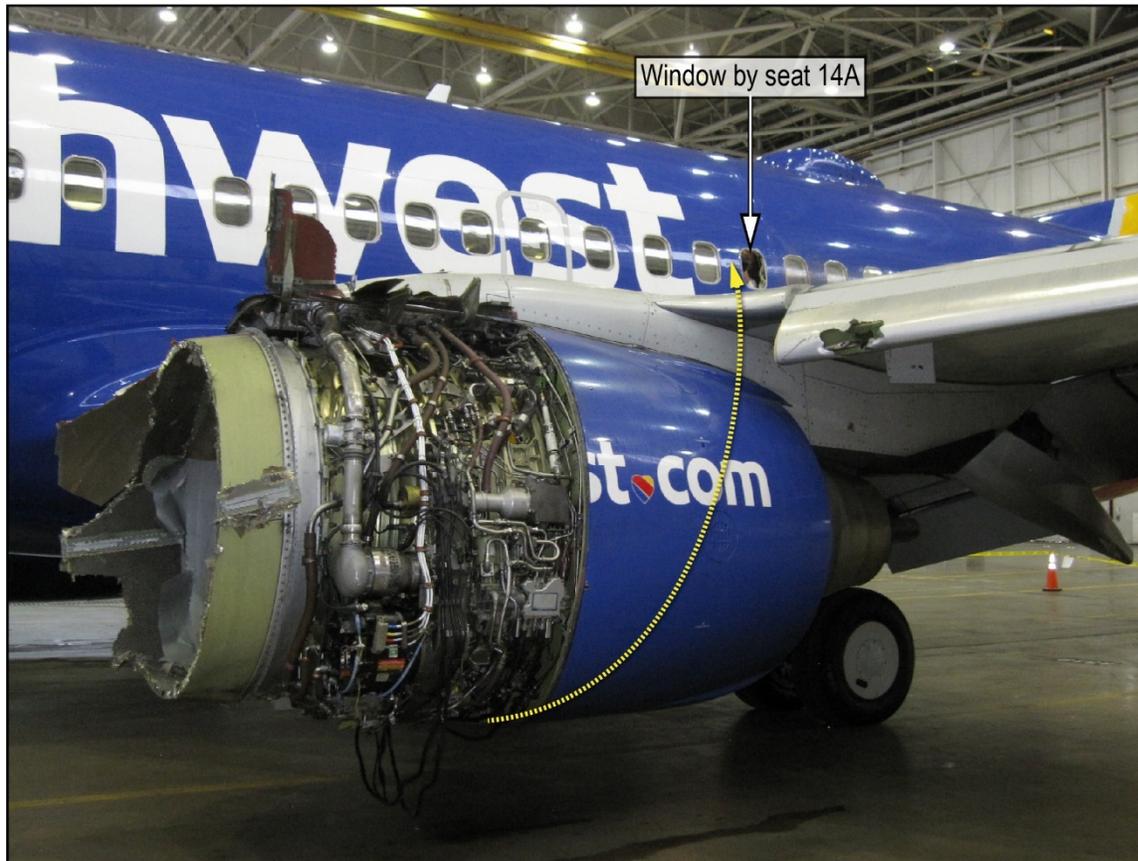
The skin stresses associated with loads transmitted to the fan cowl through the radial restraint fitting resulted in fractures initiating around the latches on the inboard fan cowl. These fractures eventually caused the inboard fan cowl structure surrounding the aft and middle latch keepers to separate. The separation of the forward latch assembly quickly followed, which allowed the fan cowls to open. The aft latch assembly (the latch keeper and latch hook) remained engaged as air loads caused both fan cowl halves to continue to open, and the aft latch keeper (on the inboard fan cowl), its surrounding support structure, and part of the inboard fan cowl skin were flung up and over the engine and the left wing. The aft latch assembly then separated, and the inboard fan cowl piece with the aft latch keeper impacted the fuselage near the window by seat 14A, as shown in figure 22. The NTSB concludes that the impact of the inboard fan cowl aft latch keeper with the fuselage near the cabin window adjacent to seat 14A caused the window to depart the airplane, the rapid depressurization of the cabin, and the passenger fatality.

**Figure 22.** Trajectory of the inboard aft latch keeper during the accident sequence.
