Air and Space Defense Corporation  
**"Almaz-Antey"**

## REPORT

on the results of studies related to the technical investigation into the crash  
of the Malaysian airlines Boeing 777-200 9M-MRD (flight MH17)

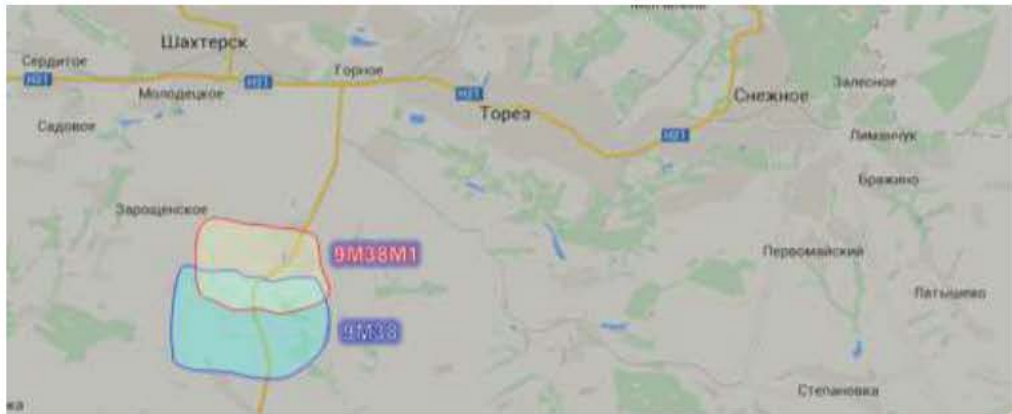
Figure 4.1 - Possible launch area: for 9M38M1 missiles (red area); for 9M38 missiles (blue area)

Table 4.1 shows the coordinate values for six points corresponding to the possible launch areas: points 1, 2, 3 and 4 correspond to the possible 9M38M1 launch area; points 3, 4, 5 and 6 correspond to the possible 9M38 launch area.

Accordingly, the most likely launch area for the 9M38 missile is limited by points 3, 4, 5 and 6 with their respective coordinates.

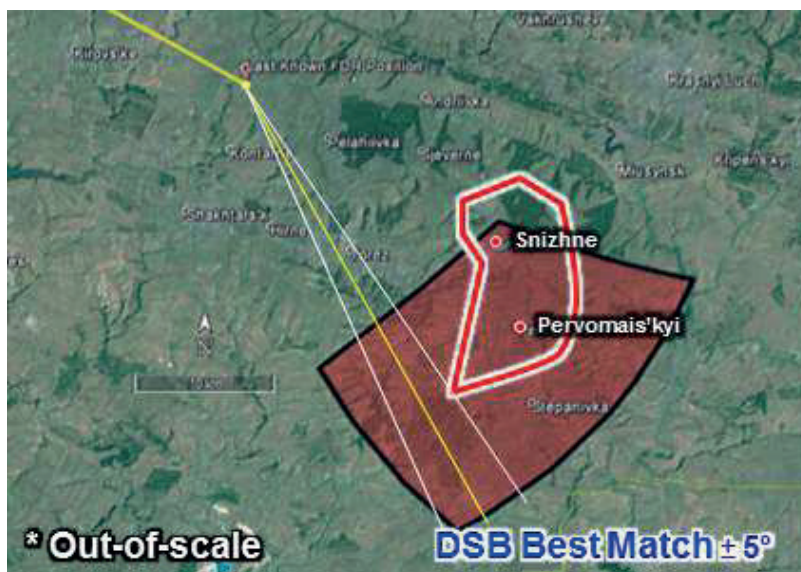
Figure 5.3.6 - "Refined Possible Launch Area" presented in the new NLR report has shifted north. "Best Match" value from Final Report

The new calculated area not only does not match the conclusions of the DSB "best fit" report obtained for -27° conditions,<sup>144</sup> but even taking into account errors of  $\pm 5$  degree excludes these conditions (see Figure 5.3.6), i.e. **directly contradicts the results obtained in the DSB-led technical investigation.**
