## DRAFT FINAL REPORT

# Crash of Malaysia Airlines Boeing 777-200, 9M-MRD, flight MH17

Hrabove, Ukraine, 17 July 2014

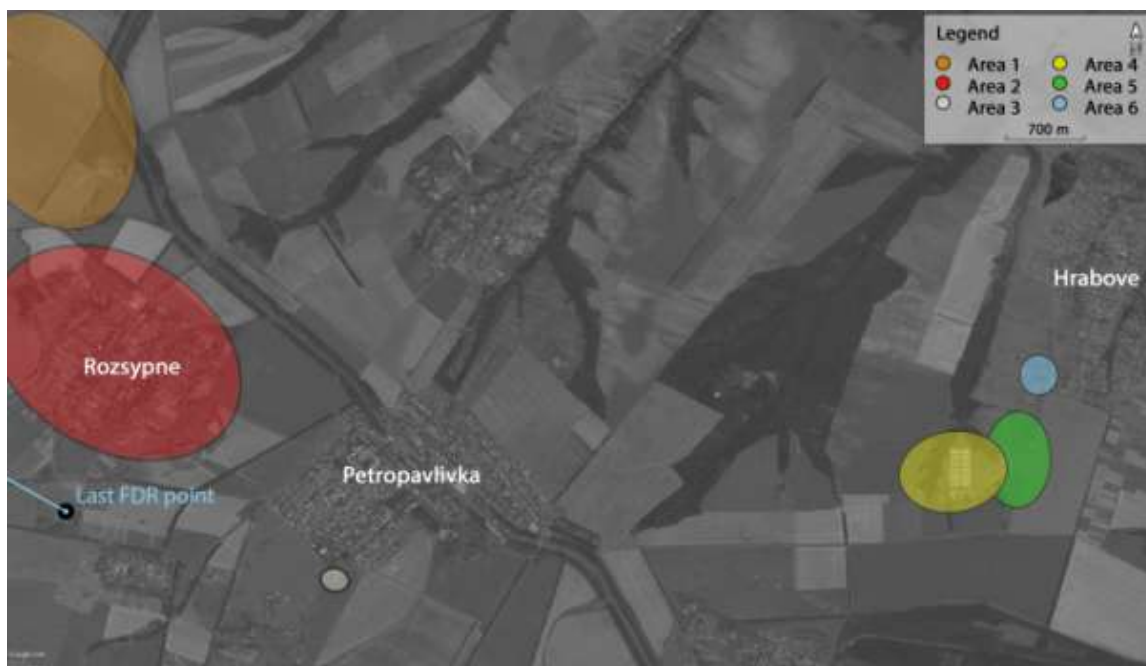
2 *Figure 12 – Overview wreckage areas with wreckage parts*

33 The wreckage parts of the aeroplane were identified in six concentrated areas to the  
34 west and south-west of the village of Hrabove, within an area of approximately 50  
35 km<sup>2</sup>. Figure 12 shows the geographic location of the six wreckage areas. Each  
36 wreckage area has an associated colour, depicted in figures 13 and 14.

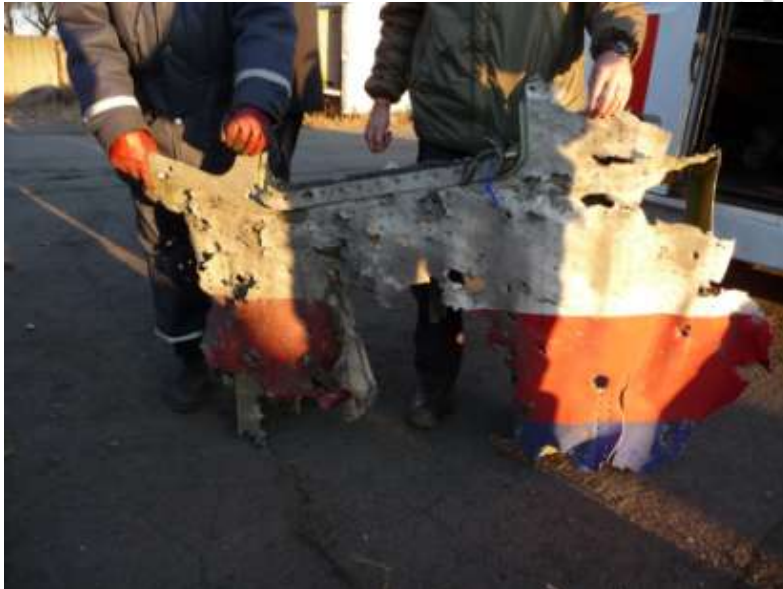
17 *Figure 19 – Handover of the left cockpit window to the DSB by members of the*  
18 *SES. (Source: DSB)*

9 The fuselage, originating from the left hand side of the cockpit, was located at the  
10 side of the road, in the central region of area 2, the village of Petropavlivka.  
11 Residents of the village reported that the wreckage piece had been moved to  
12 expedite the search and recovery mission (Figure 19). The fuselage contained  
13 numerous puncture holes and pitting and showed traces of soot. Frames on the  
14 inner side of the fuselage had been sheared.

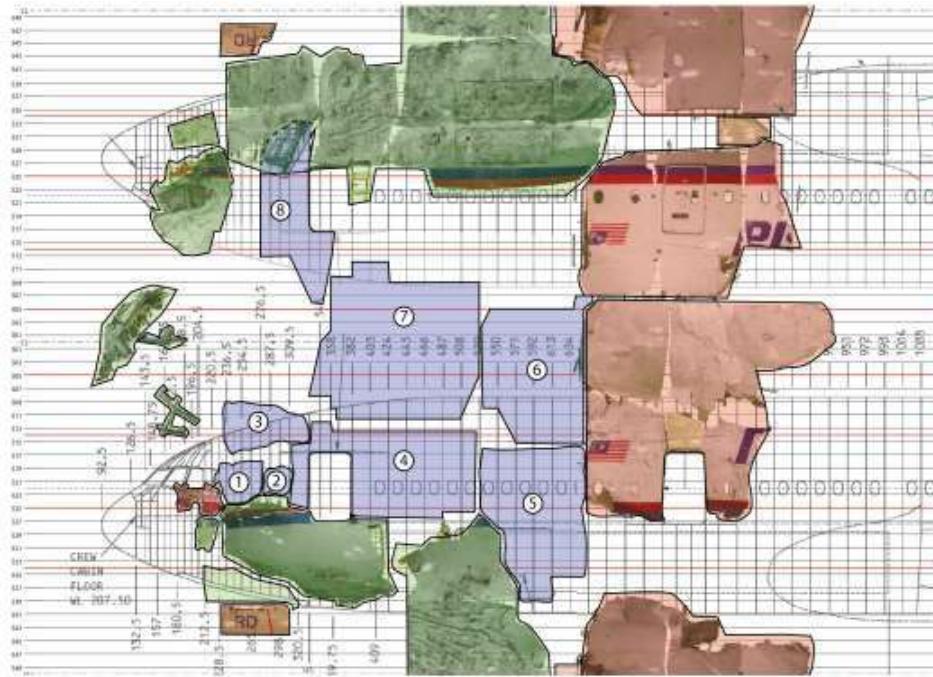
28 For the forward fuselage section up to about STA1032 a digital two-dimensional  
29 reconstruction was made. The approach was to first generate a grid consisting of all  
30 fuselage frames and stiffeners positions. Subsequently, the green-screen photos  
31 that were made of structural parts were positioned onto the grid at the right scale  
32 and orientation. The resulting final image is shown in Figure 52.

1  
 2 *Figure 52 – Grid reconstruction of the outside skin of the forward fuselage. Overlaid*  
 3 *outline indicates approximate boundary of the piece prior to dismantling for transport*  
 4 *to the Netherlands. Colour indicates wreckage site.*

5  
 6 *Note:*  
 7 *Unrecovered pieces are highlighted in blue and were reconstructed based on*  
 8 *accident scene photos. Piece A indicates a piece of skin attached to the nose*  
 9 *landing gear bay for which photographs are not available. All show tearing and*  
 10 *peeling damage. Close examination of the wreckage parts available revealed no*  
 11 *evidence of pre-existing structural faults (such as fatigue, corrosion or mechanical*  
 12 *damage) that could have contributed to the in-flight break-up.*
