Left Engine Failure and Subsequent Depressurization  
Southwest Airlines Flight 1380  
Boeing 737-7H4, N772SW  
Philadelphia, Pennsylvania  
April 17, 2018

NTSB/AAR-19/03  
PB2019-101439

National  
Transportation  
Safety Board

# Aircraft Accident Report

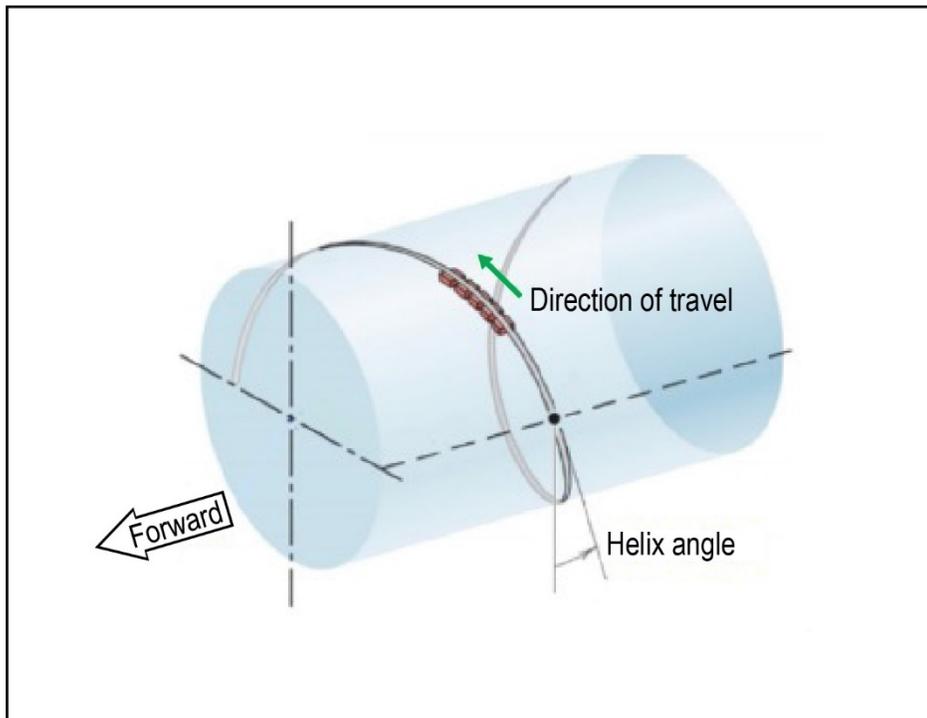
FBO rig test 4, which was conducted in August 1995, revealed that the separated fan blade fractured into five pieces with the blade tip panel traveling forward of the fan case and into the inlet at an estimated 10° to 15° helix angle (where the fragment crossed the A1 flange).<sup>51</sup> Figure 11 shows a general example of a helix angle. The blade tip panel spiraled around the inlet and then penetrated the inlet inner and outer barrels. The inner barrel penetration was about 26° forward of

the fan blade rotational plane, which was beyond the  $\pm 15^\circ$  fragment spread angle (impact area) referenced in AC 20-128 (see section 1.3.5.3) as a practical design consideration to minimize the hazards of uncontained fragments. The test also revealed a small penetration hole in the fan case. Further, the test revealed that the fan blade axial retention feature allowed some blades to slide forward.

**Figure 11.** General example of a helix angle.

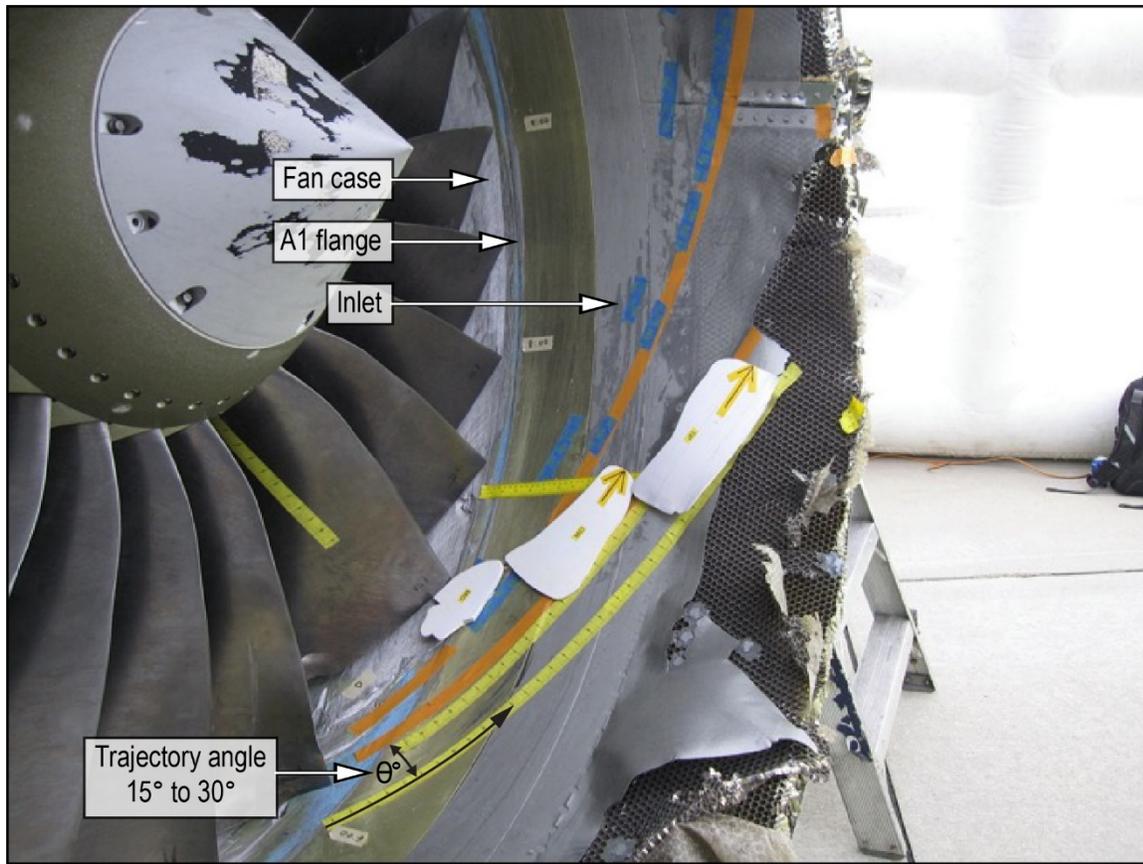
Some of the fragments from the accident fan blade were not recovered, but the recovered fan blade fragments showed that the mass of the fragments that exited the engine was likely similar to (and possibly greater than) the mass of the exiting fan blade fragments observed during the CFM56-7B engine FBO rig tests and containment certification tests. The likely exit trajectory of the fan blade fragments during the accident sequence (based on the observed damage to the fan case and the inlet) was between 15° and 30°, as shown in figure 12.<sup>61</sup> (Figure 11 shows a general example of the forward spiral/helical pattern that fan blade fragments generally travel.) The engine FBO rig tests and the engine FBO containment certification tests provided evidence indicating that the fan blade tip exit trajectory would be 15°, which was used to design and certify the inlet. The exit trajectory for mid-span fragments was not defined during the engine certification tests because the fan blade tip was considered to have more energy.

<sup>61</sup> The precise trajectory of the fan blade tip and mid-span fragments that departed the engine could not be determined because of the numerous impact and scuff marks in both the fan case and the inlet as well as the possible orientations of the fan blade fragments at the time that the marks were created.

**Figure 12.** Fan blade fragment exit trajectories.
